SUBJ: RCRA Compliance Evaluation Inspection
Phifer, Inc.
EPA ID Number: ALD0040022853

RCRA Inspection Report

EPA-RCRA CEI Report
Phifer, Inc.
ALD0040022853
November 27, 2017

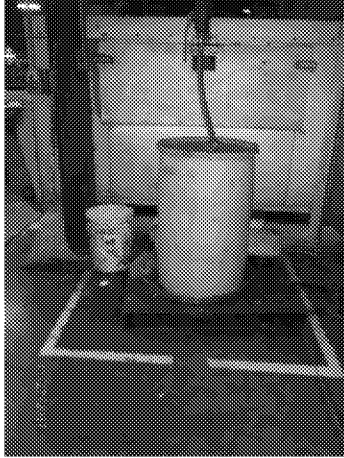
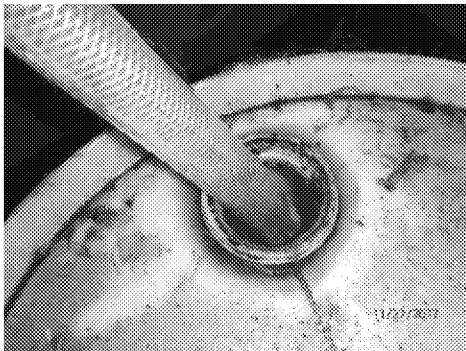
The Yarn Coating Department has fourteen coating lines that generate plasticizer precipitation (gold used oil) from the air pollution control devices. Lines 1 and 2 have two 30-gallon drums (Pictures 1-2) assigned to capture the used oil. The remaining coating lines have only one drum per line. No hazardous waste was observed in this area.

Picture [SEQ Picture * ARABIC] – Yarn Coating
Department Line 1 used oil

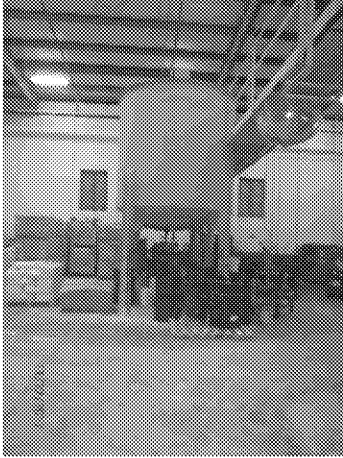
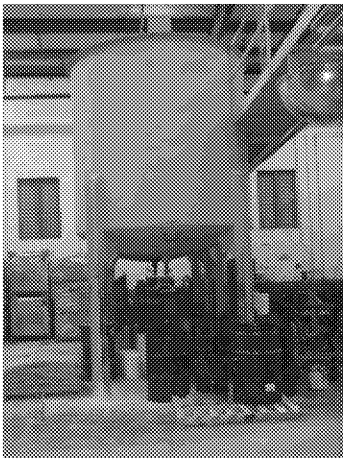
Tank 19 is used to consolidate off-specification vinyl compounding mixing ingredients, coating material generated from color changes in the Yarn Coating Department and the cleaning of the applicators with kerosene prior to a color change (Pictures 3-4). The inspectors observed open 55-gallon drums of off-specification coating underneath Tank 19 (Pictures 5-8). Mr. Stumpff stated that these drums will be added to the tank. The inspectors also observed the floor around Tank 19 was covered in dried off-specification coating.

Picture [SEQ Picture * ARABIC] – Plasticizing
Compound Room Tank 19

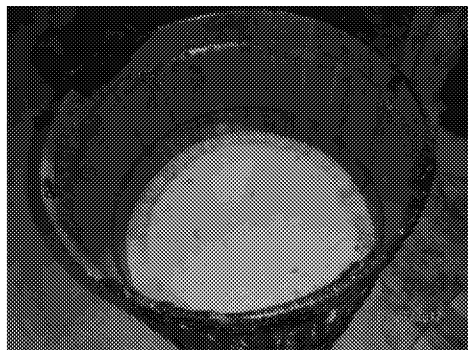
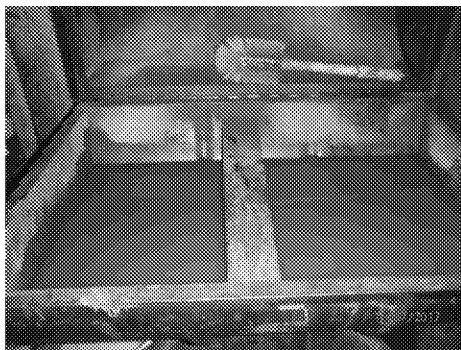
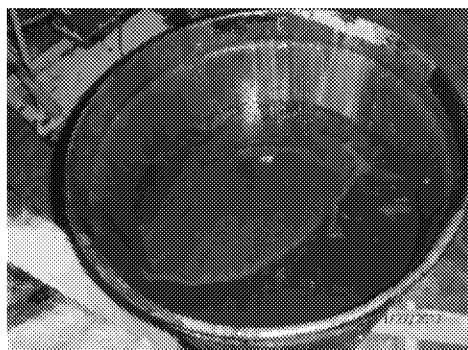
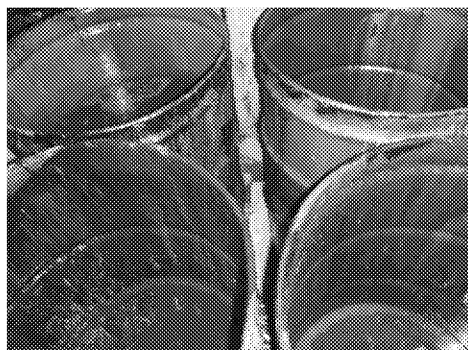
In addition to off-specification coating, used kerosene used in the parts washers and the die vibratory cleaners are added to Tank 19.

Picture [SEQ Picture * ARABIC] – Plasticizing
Compound Room applicator cleaning drum

Picture [SEQ Picture * ARABIC] – Plasticizing
Compound Room parts washer

Picture [SEQ Picture * ARABIC] – Plasticizing
Compound Room color changing drum

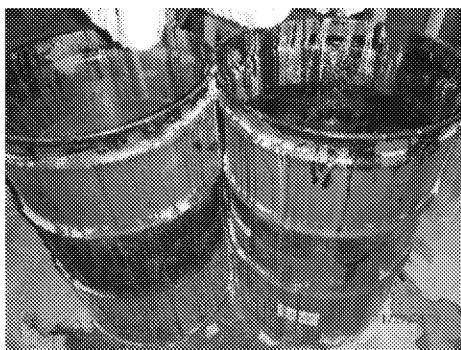
Across from the tank were two 55-gallon drums capturing coating from leaking equipment (Picture 9). These drums will also be added to Tank 19. Beside the drums on the floor was spilled coating. Mr. Stumpff stated that the spilled coating will be cleaned up before the shift leaves.

Picture [SEQ Picture * ARABIC] – Plasticizing
Compound Room leaking equipment drum

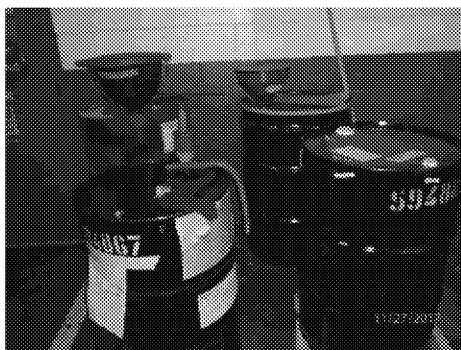
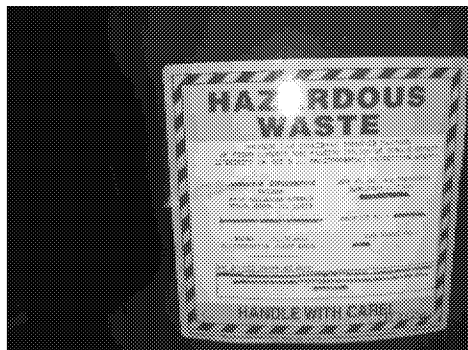
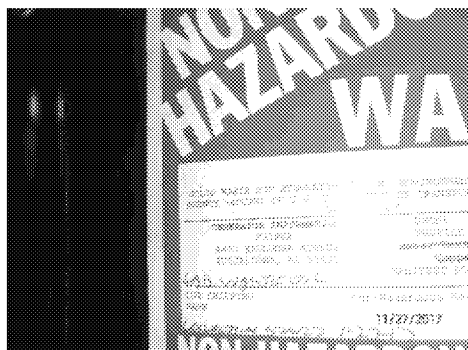
The QC laboratory generates used oil from lubricant viscosity testing and hazardous waste from lab components. Outside the lab, the inspectors observed a satellite accumulation area with a 55-gallon drum of hazardous lab waste and a 55-gallon drum of used oil incorrectly labeled as "Waste Oil" (Pictures 10-12). The inspectors recommended for clarity that the label be changed to "Used Oil" to properly reflect the contents of the drum.

Picture [SEQ Picture * ARABIC] – QC Lab SAA

Picture [SEQ Picture * ARABIC] – QC Lab SAA hazardous waste drum label

Picture [SEQ Picture * ARABIC] – QC Lab SAA used oil drum label

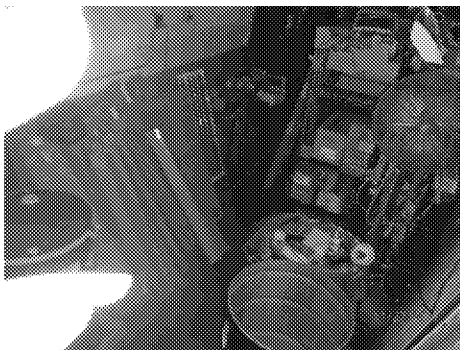
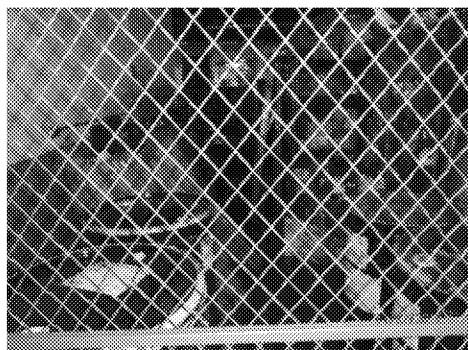
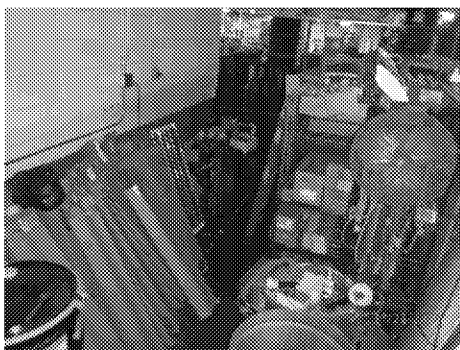
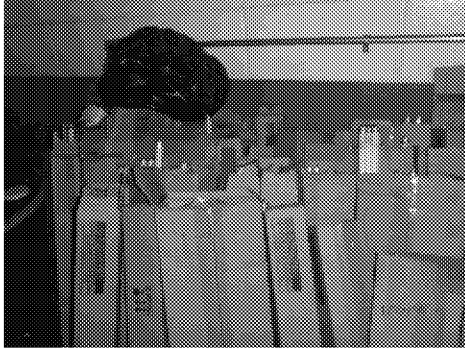
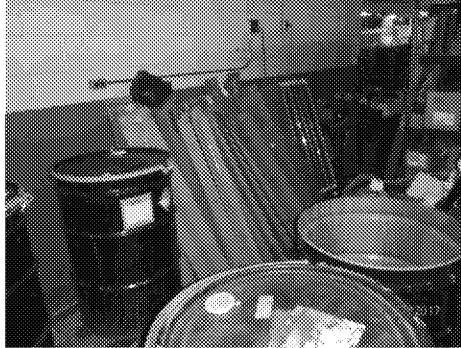
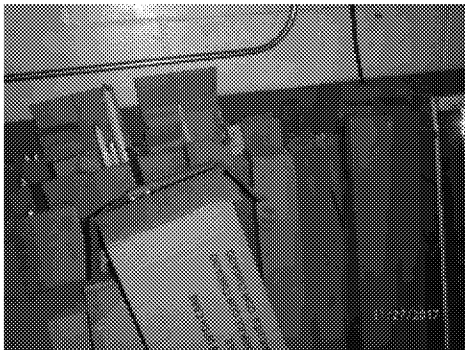
The spent fluorescent lamps are stored in a locked fenced area inside the Metal Wire Building (Pictures 13-20). At the time of the inspection, the inspectors observed spent 4-foot fluorescent lamps stored in 30 open and unlabeled boxes.

Pursuant to ADEM Admin. Code r. 335-14-3-.03(5)(d)2 [40 C.F.R. § 262.34(d)(2)], which incorporates ADEM Admin. Code r. 335-14-6-.09(4)(a) [40 C.F.R. § 265.173(a)], and is a condition of the SQG Permit Exemption, a generator is required to keep containers of hazardous waste closed when waste is not being added or removed.

Pursuant to ADEM Admin. Code r. 335-14-3-.03(5)(d)5 [40 C.F.R. § 262.34(d)(4)], which incorporates ADEM Admin. Code r. 335-14-3-.03(5)(a)3. [40 C.F.R. § 262.34(a)(3)], and is a condition of the SQG Permit Exemption, a generator is required to label or clearly mark each container accumulating hazardous waste with the words: "Hazardous Waste."

Picture [SEQ Picture * ARABIC] – Metal Wire Building spent lamp storage

Picture [SEQ Picture * ARABIC] – Metal Wire Building Lamp Storage

Picture [SEQ Picture * ARABIC] – Metal Wire
Building spent lamp storage

On November 28, 2017, Mr. Stumpff emailed “Please find attached our lamp service area in much better condition. Going forward, TC has been instructed to crush every spent lamp accumulated during his shift.” Attached to the email was a photograph of the cleaned area and the labeled hazardous waste drum.

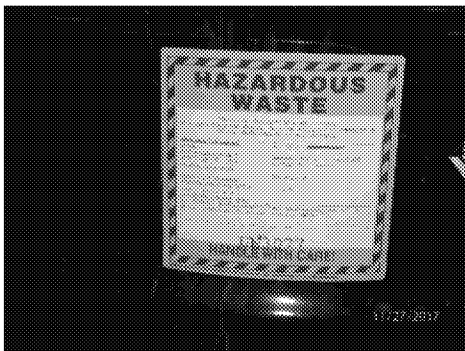
Mr. Stumpff explained that the lamps were collected and crushed in a bulb crusher by one employee named TC. The bulb crushing system was disconnected from the drum and set aside. A 55-gallon drum was stored next to the open boxes of spent lamps. The drum was full, closed, labeled as hazardous waste but did not a start accumulation date.

Pursuant to ADEM Admin. Code r. 335-14-3-.03(5)(d)5 [40 C.F.R. § 262.34(d)(4)], which incorporates ADEM Admin. Code r. 335-14-3-.03(5)(a)2. [40 C.F.R. § 262.34(a)(2)], and is a condition of the SQG Permit Exemption, a generator is required to ensure that the date upon which each period of accumulation begins is clearly marked and visible for inspection on each container.

Picture [SEQ Picture * ARABIC] – Metal Wire
Building spent lamp storage drum label
